SPARROW RISK GROUP

Residential Security Assessment:

Location: Private Residence

123 MAIN ST
ANYWHERE, MA

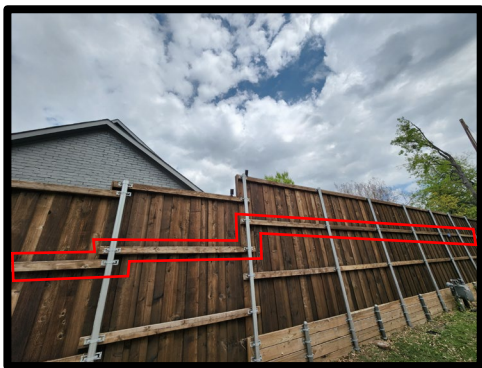
Horizontal support beams located on outside

- 2x4 support beams are located on the outside of the fencing into an alley. This alley provides adequate coverage to scale perimeter fencing with minimal risk of detection.

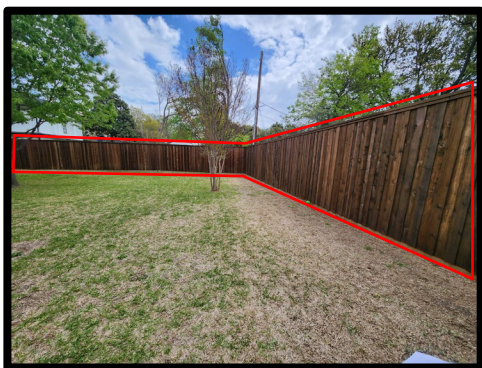
Privacy fencing provides a threat actor with coverage from outside surveillance from neighbors or police once the outer security layer is penetrated.

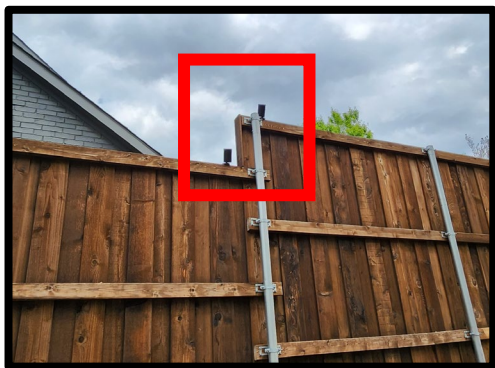
Batteries on fence mounted Ring "Stick Up" cameras are dead-leaving the entire C-side exposed to outer security ring penetration.

NOTE: Ring units dead on C-Side fence, internal battery power.

1.2	Removal of Ring devices prone to short battery life, replacing with a new provider, creating a seamless security surveillance system. <u>SRG can source</u> (Page 7)	1

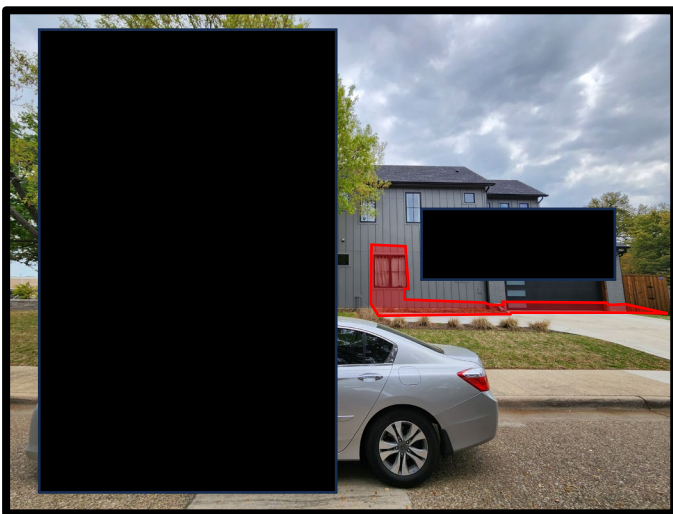
Path of Approach

Entry onto the property from C-Side perimeter.

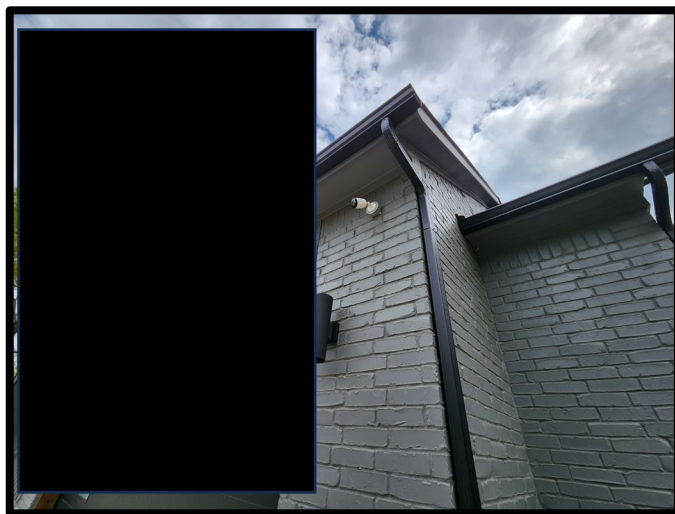
Camera Angle

Cameras vertical angle coverage is exploitable.

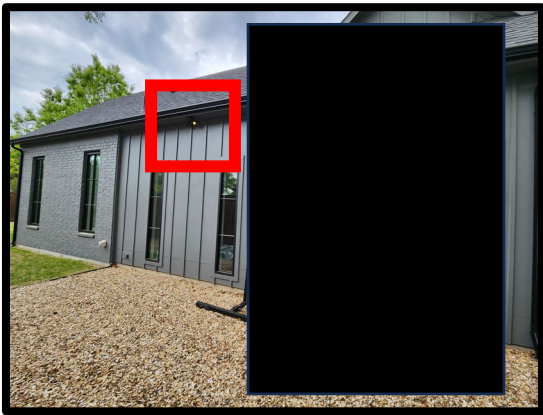
Hardwired motion sensor lights should be upgraded.

Even the most advanced Infrared (IR) capable cameras lose resolution when operating under IR assistance. Proper lighting allows the highest resolution possible with installed surveillance.

1.3	Most likely approach is from the C-Side of home. Installation of LED motion activated lighting around home, with priority being the A-Side and C-Side of property. Adequate lighting will also assist surveillance cameras. (Pages 10)	2

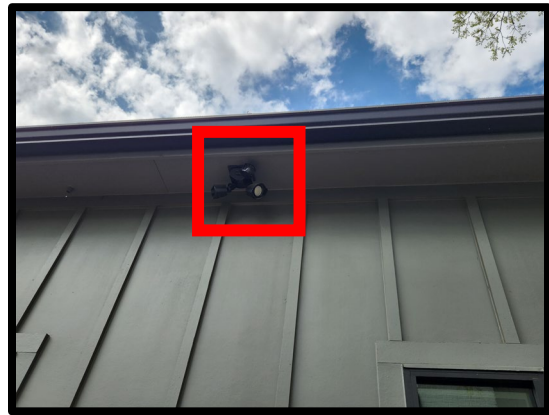
Lumens on current security lighting are low due to age, debris buildup, and light type. The current output will have little effect on surveillance system assistance or visual identification.

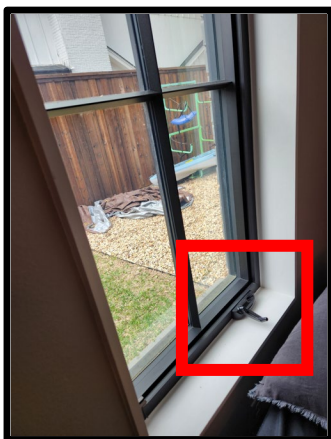
Casement windows with aluminum locking mechanisms.

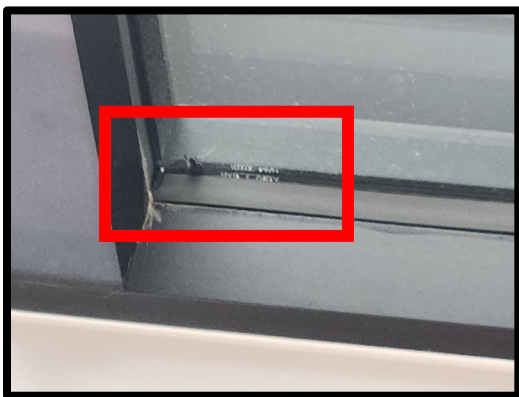
Sliding glass door into the living room

Tempered glass markings from glass manufacturer.

Advances in the development of security window films further enhance brute force entry deterrence and overall safety. Larger glass doorways should have security film installed.

Security film used in conjunction with glass break sensors creates an effective redundancy of security layers.

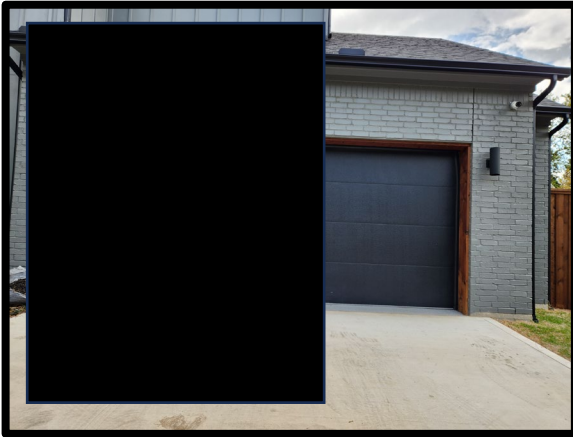
Garage has no exterior handle and frosted privacy windows making exploitation of emergency release chord difficult.

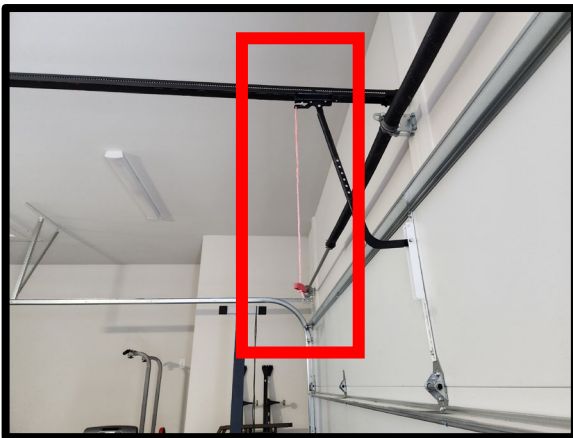
Purpose-made tools are designed and marketed to exploit the existence of emergency release chords in garages leading into the home. These releases are positioned in the center of the door, so visibility inside the garage is unnecessary for trained individuals to perform such attacks.

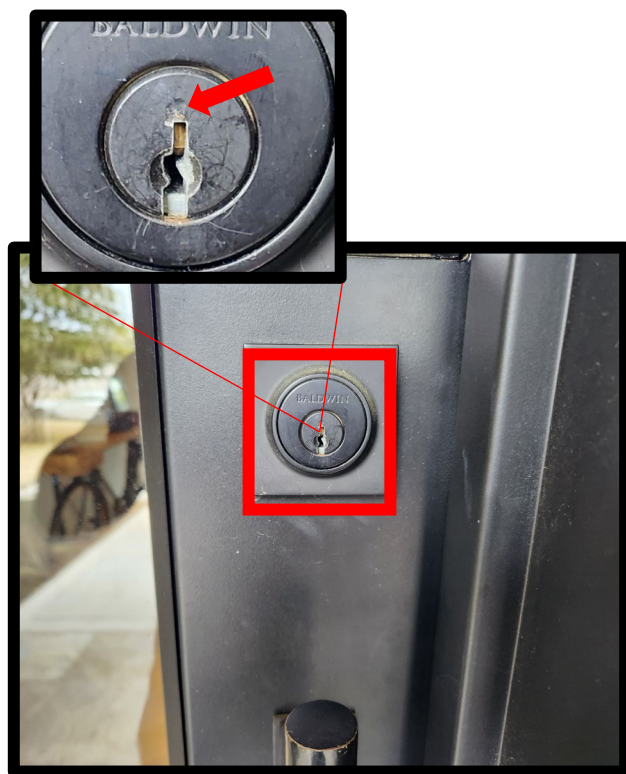
Defiant locks are considered a low-security solution. They are built outside the US, with a major contract with Home Depot as a discount lock option.

Dimpling seen on top of keyway suggests the lock has been “bumped” in the past as a bypass method.

1.6	Replacement of locks and lock hardware to ensure heightened security, key control, and proper function. (Page 13)	1
1.7	Replace signage with company other than that being used. Old sign can be used once updated.	2

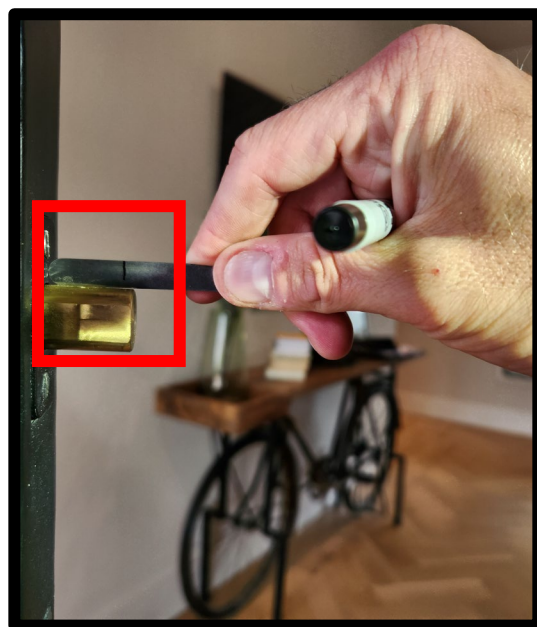
Deadbolt installed improperly. Allowing simple exploitation by “walking” the deadbolt back.

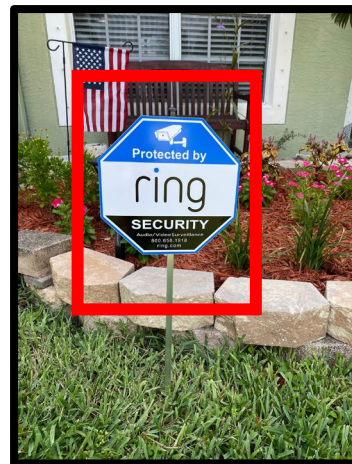
Signage identifying current security provider allows trained threat actors to conduct social engineering attacks by impersonating the client, granting access to sensitive information.

Utilizing a sign for a different company, therefore, a different operating frequency is advised to make signal exploitation more difficult.

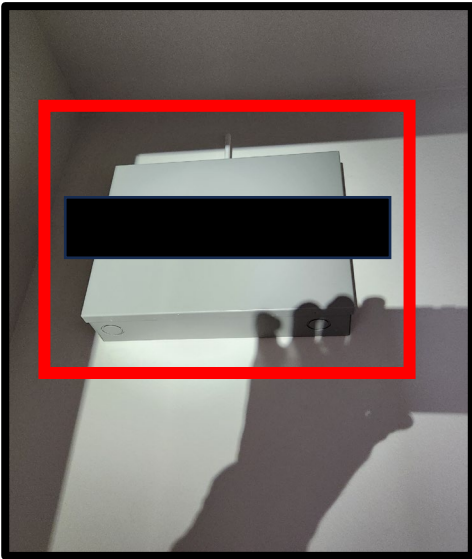
The wired alarm box is located approximately 9 feet off the ground. Access requires a step stool or ladder.

Moderate security wafer lock located on box, adding additional hurdles for potential exploitation.

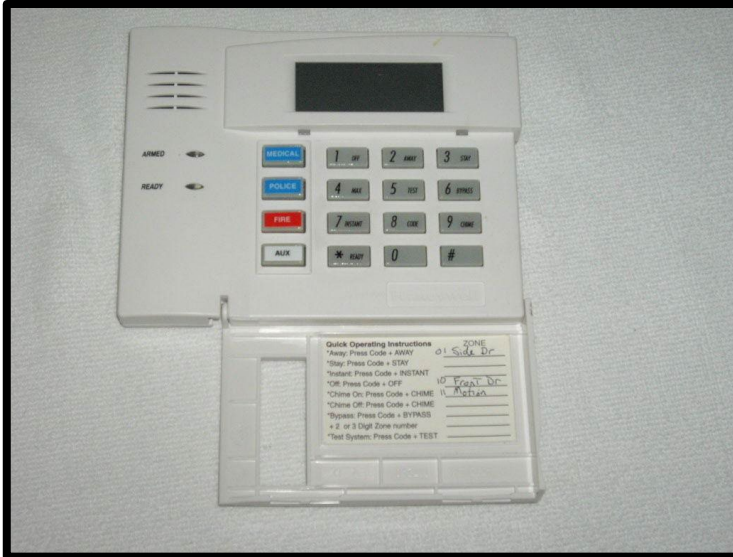
Keypad is in working order.

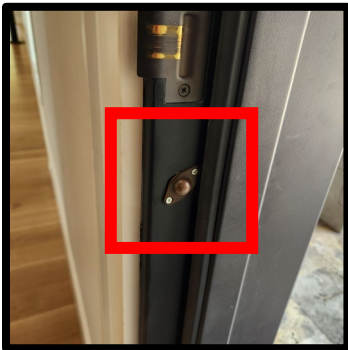
Hardwired Plunger Sensor

Plunger sensor on main entrance. Placement allows for immediate visual identification for threat actor posing as visitor while in the reconnaissance phase for attack vectors.

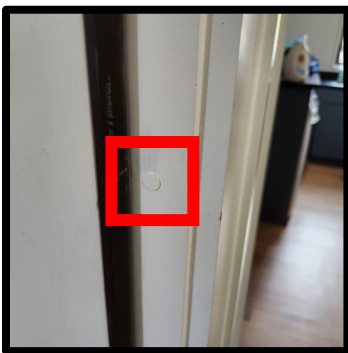
Recessed Magnetic Contact Sensor

Recessed entry sensor installed on entry door from garage.

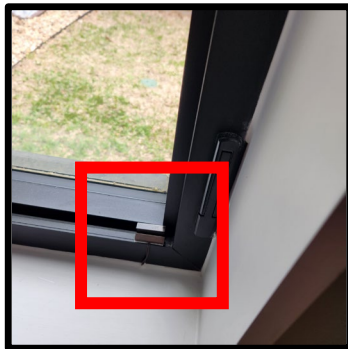
Exposed Magnetic Contact Sensor

Exposed magnetic contact sensor on all remaining casement windows and sliding glass doors.

Exposed sensors allow for external location ID and exploit planning

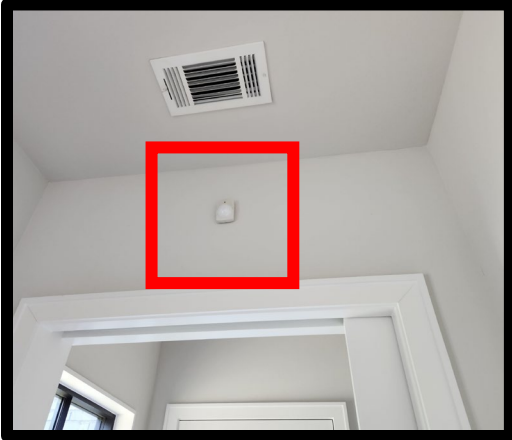
PIR Motion Sensor located at end of the hallway near garage entrance. Deliberate movement from living room to stairway does not trip motion sensor due to distance.

No.	Action Recommended	Tier
2.1	Due to access control considerations from past security teams, as well as potential knowledge of current specifics, it is recommended a new security company be sourced and update system using existing wiring. <u>SRG can source</u> (Page 17)	1
2.2	Motion sensor placement not effective. Recommend relocating sensors and adding 2-3 more to cover entirety of home. <i>Included with system upgrade.</i> (Page 18)	1
2.3	Overview of successful covert entry attempt conducted on property. (Page 19)	1
2.4	Acoustic glass-break sensors should be installed throughout home. Maximum 15ft from sensor to coverage area. (Page 20)	1
2.5	Keep vehicle keys away from doors or low windows. Dedicated router for any security devices on a network. Removal of signage identifying power to security system items. (Page 21)	2

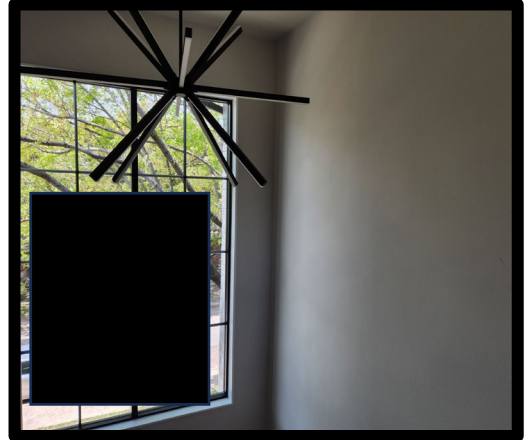
No motion sensor covering the stairway to the second floor. Positioning of first-floor sensors makes stairway access possible.

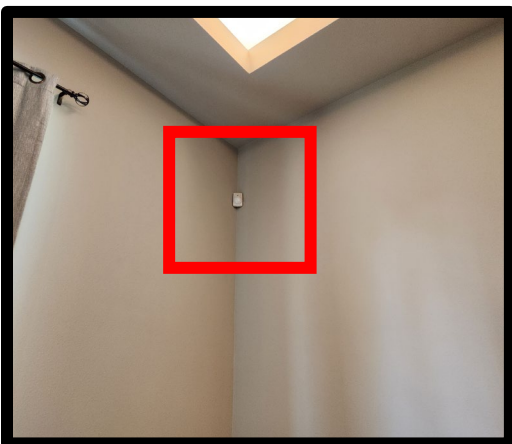
Motion sensor placement in master bedroom allows deep entry into the room before tripping.

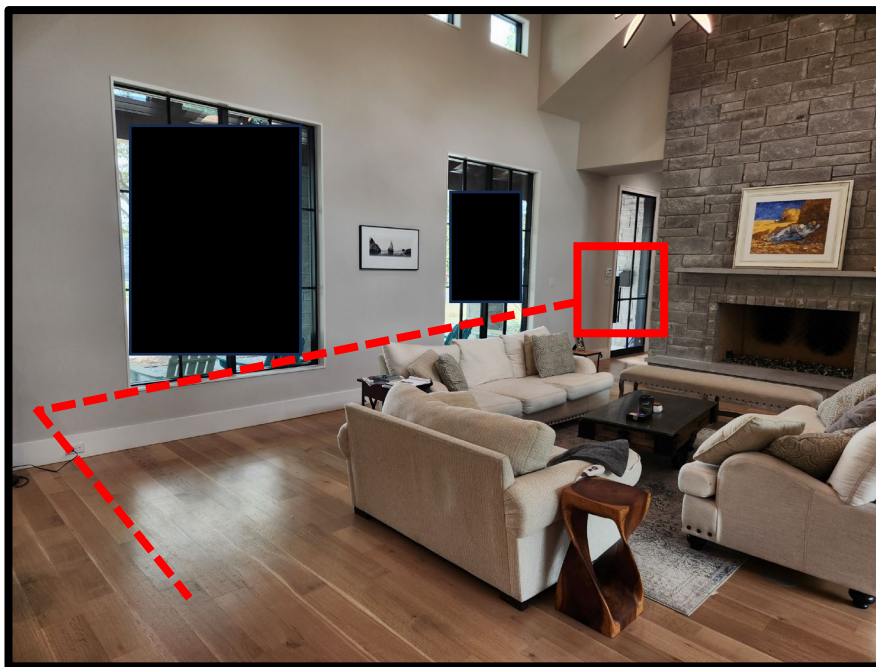
- Front door lock can be exploited due to improper installation of deadbolt.
- Alarm sensor easily identifiable so exploitation can be planned.
- Motion sensor coverage not effective with path of travel outlined.
- Successful entry into dining room, kitchen, and family room without detection.
- Successful movement onto second floor was attempted and successful without PIR motion sensor detection.

Deliberate movement along this path will stay out of detection range for both sensors on the floor.

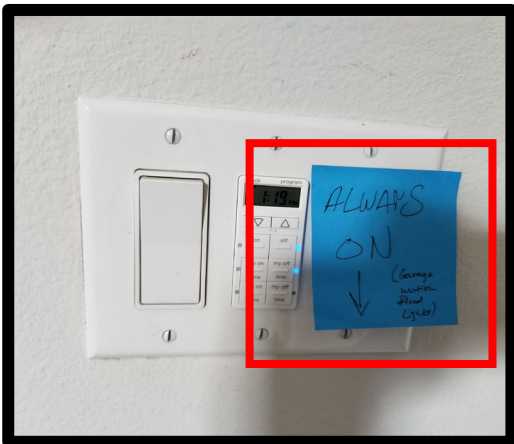
Labeling of control switch for security lighting. Identifies a way to lower security posture quickly and covertly.
