SPARROW RISK GROUP

Residential Security Assessment:

Location: Private Residence

123 MAIN ST
ANYWHERE, MA

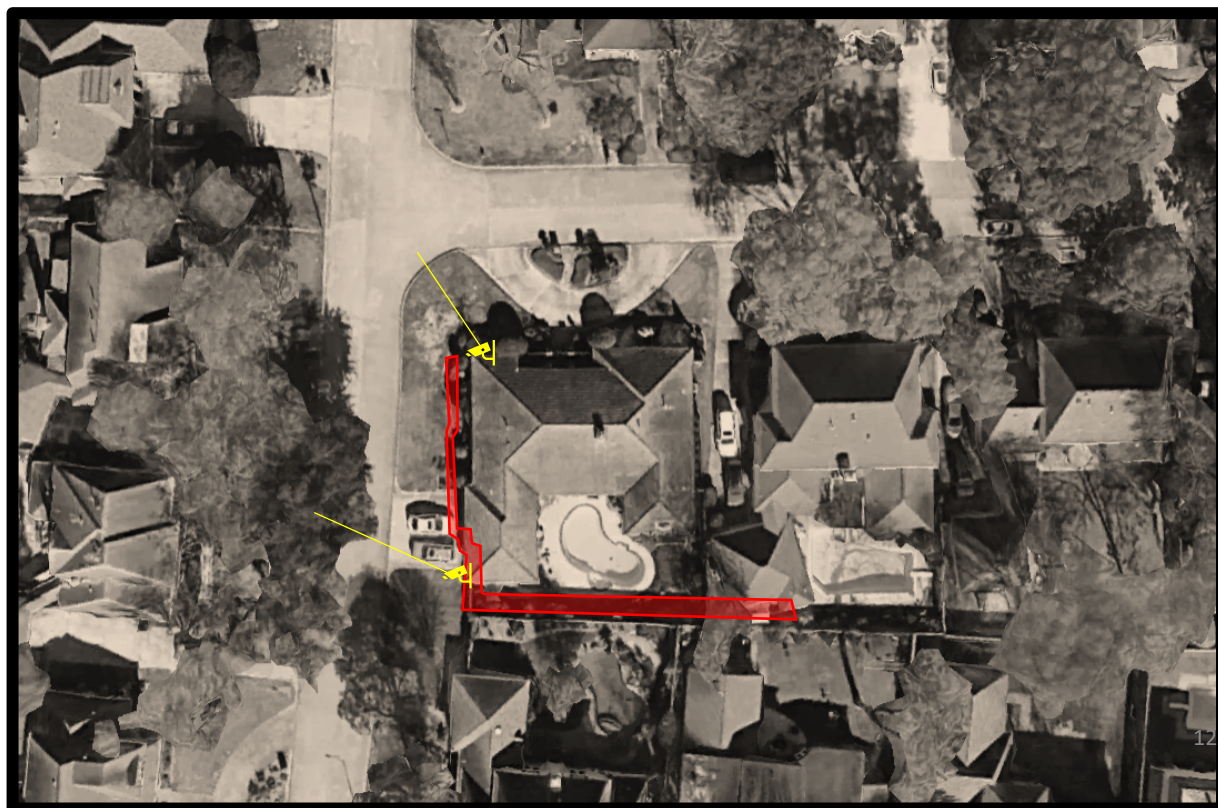
Ring cameras have a documented 2-4 second delay on motion activation to recording. Threat actors can exploit this, using the delay to conduct signal jamming or physical exploitation by removing or covering lenses with tape.

NOTE: Ring units dead on C-Side fence, internal battery power.

The C-Side (rear) of the property is adjacent to an alley providing adequate cover for movement and intent. This, in addition to fencing vulnerability (see page 7) make this the most likely path of approach from unskilled actors looking to gain access.

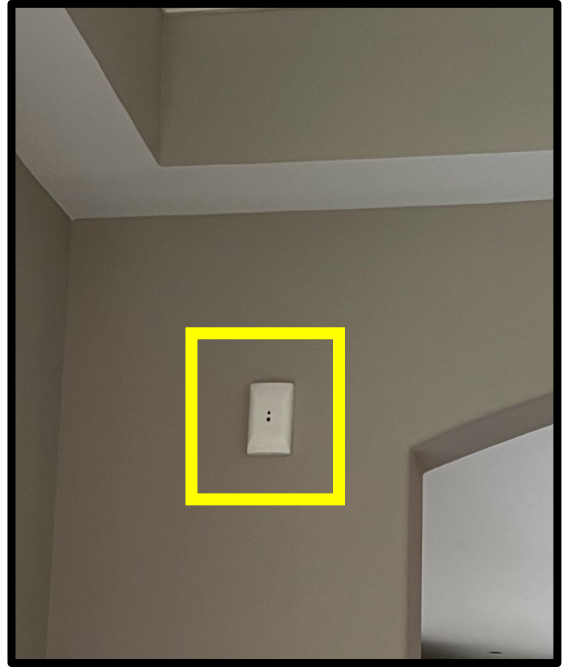
Acoustic Glass Break Sensors Not Present

Example of wall mounted acoustic glass-break sensor.
